Study Area Location Map
Lower Passaic River Restoration Project

Lower Passaic River Restoration Project

Photolog of Shoreline Conditions and Surrounding Habitat

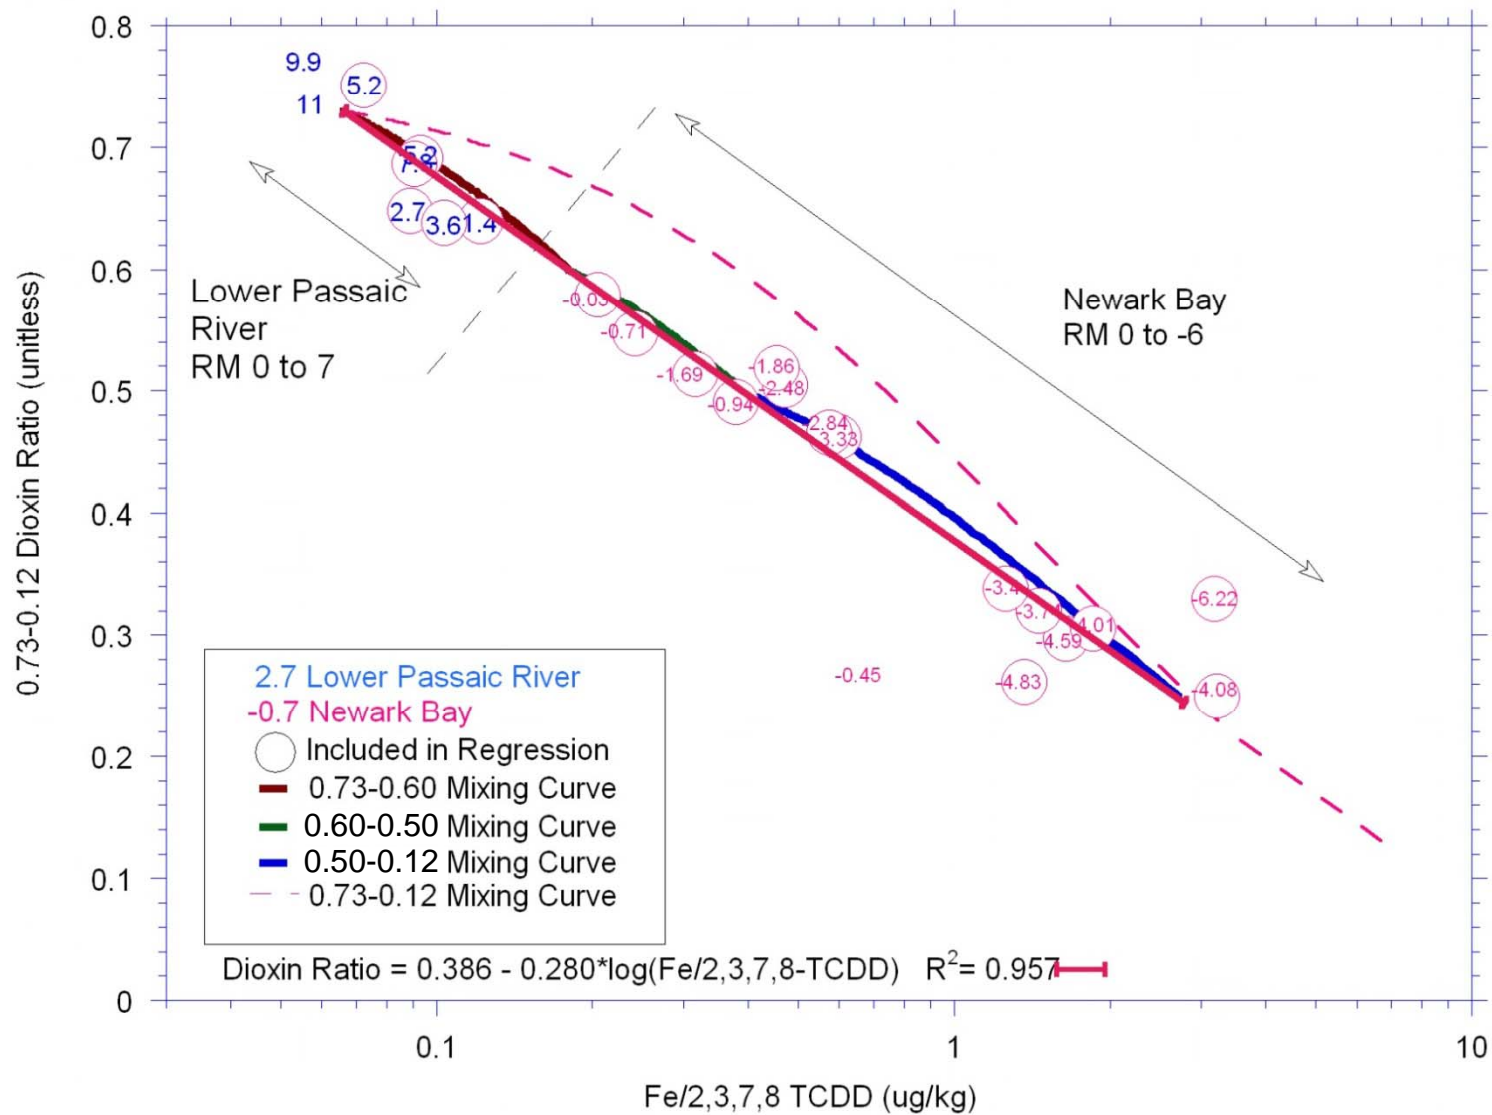
Figure 6-15

**Dioxin Results and Multiple Mixing Curves for
the Lower Passaic River and Newark Bay**
Lower Passaic River Restoration Project
